Soil Remedy: Hot Spot Removal & Capping

MCCORMICK AND BAXTER
CREOSOTING COMPANY SITE
Portland, Oregon

Groundwater Remedy:

Sediment Remedy:

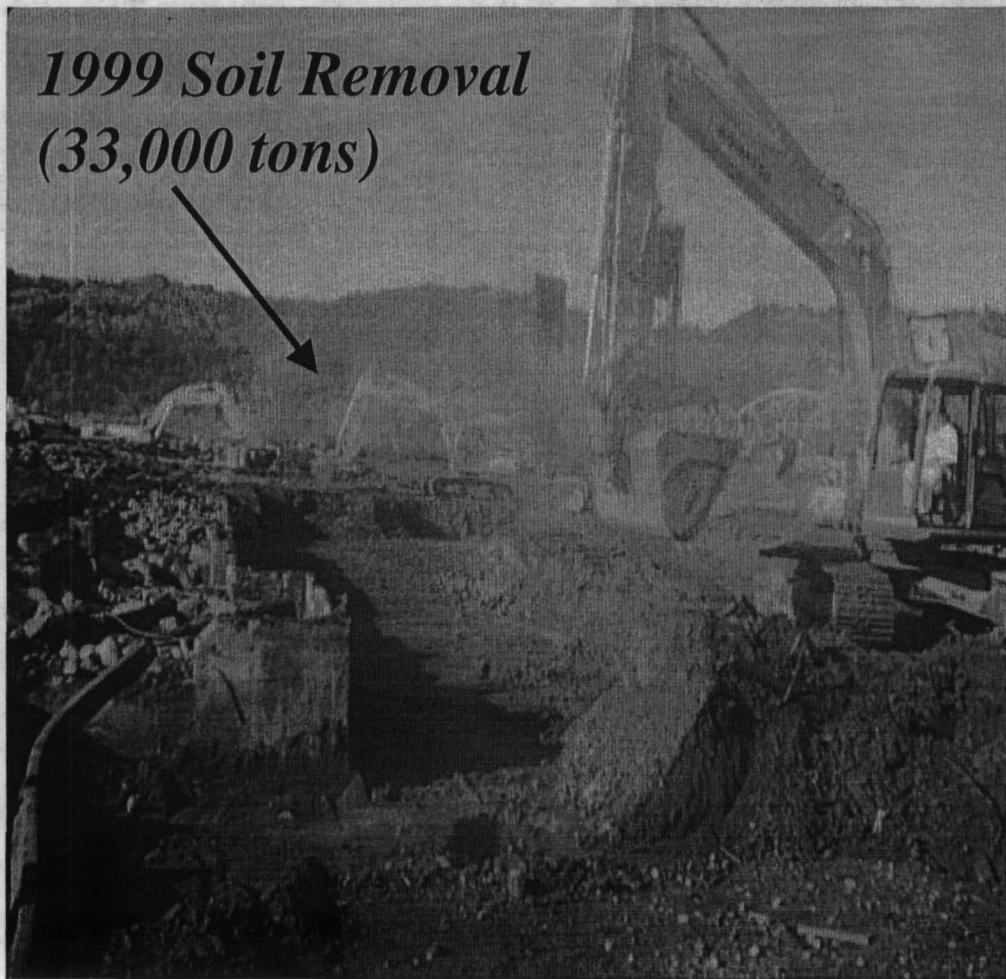
***1999 Soil Removal
(33,000 tons)***

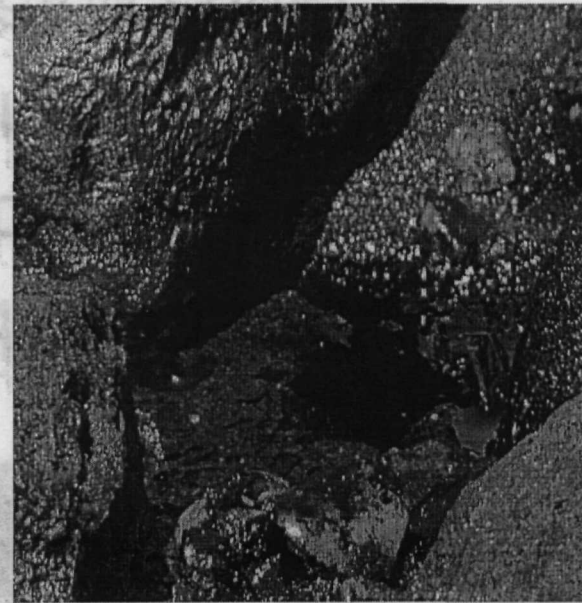
- Continued discharge of creosote into river
- Enhanced creosote extraction not cost-effective

Creosote seeps in Willamette Cove (summer 2001)

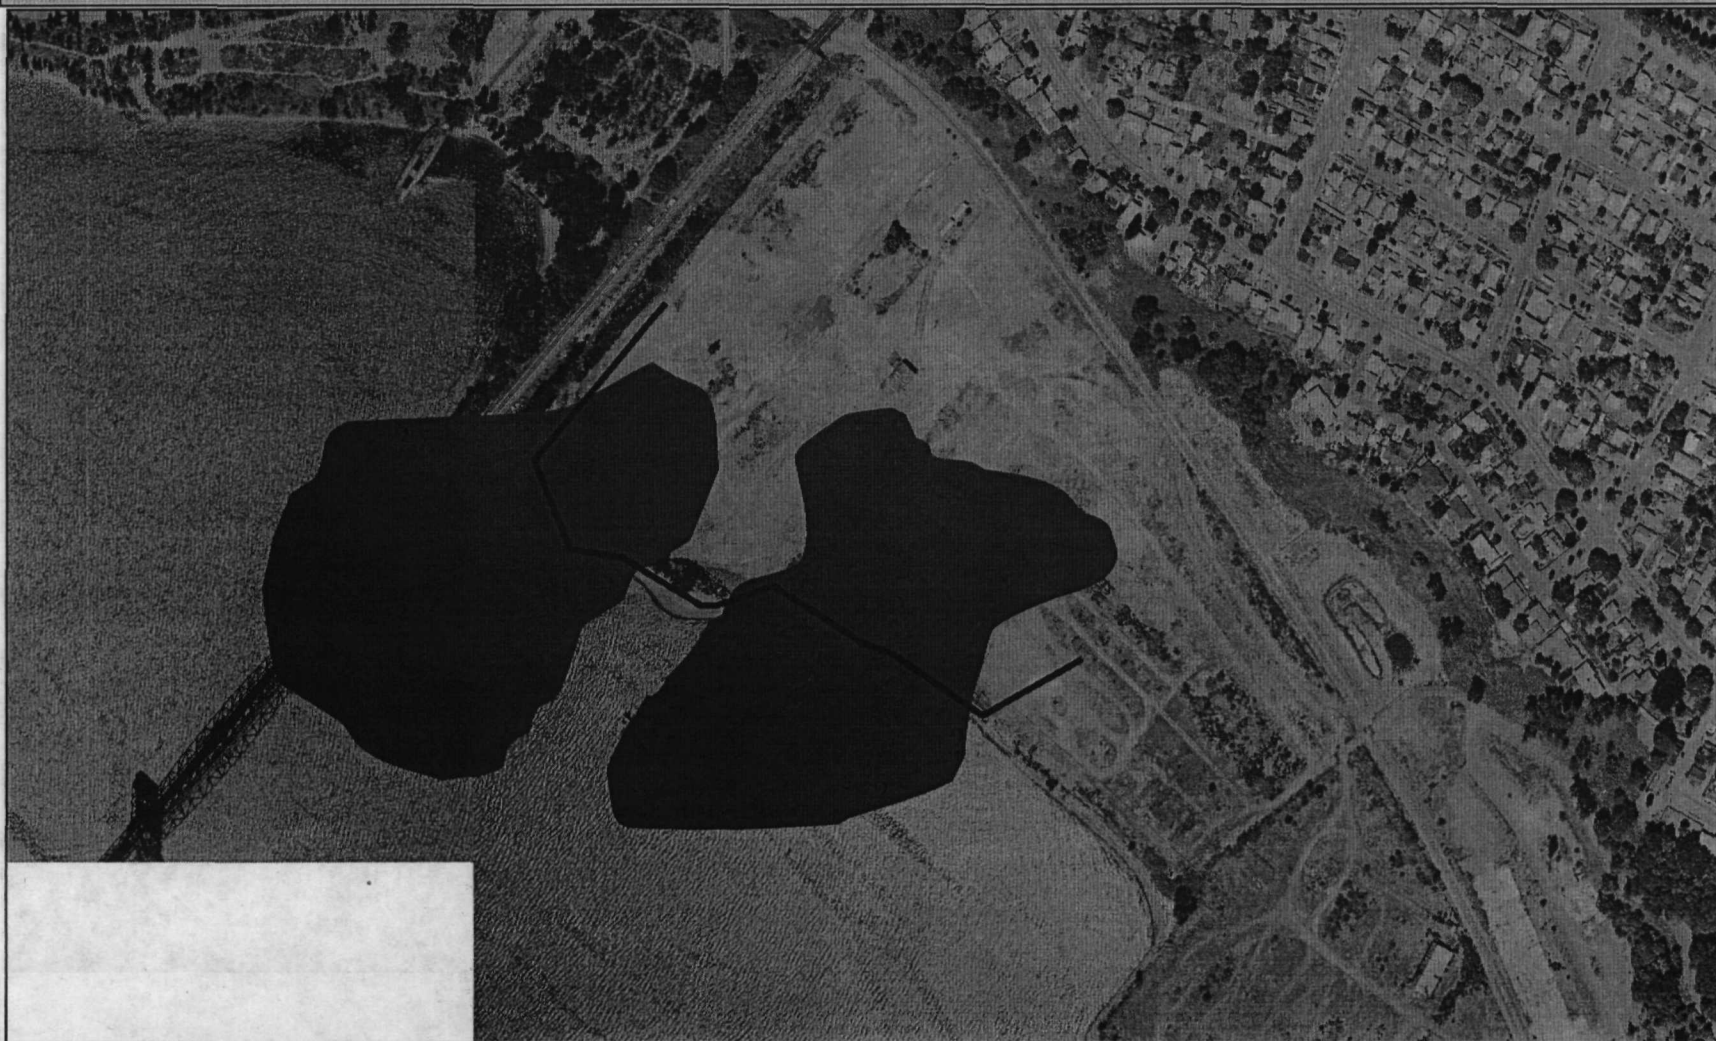
Extent of NAPL Contamination

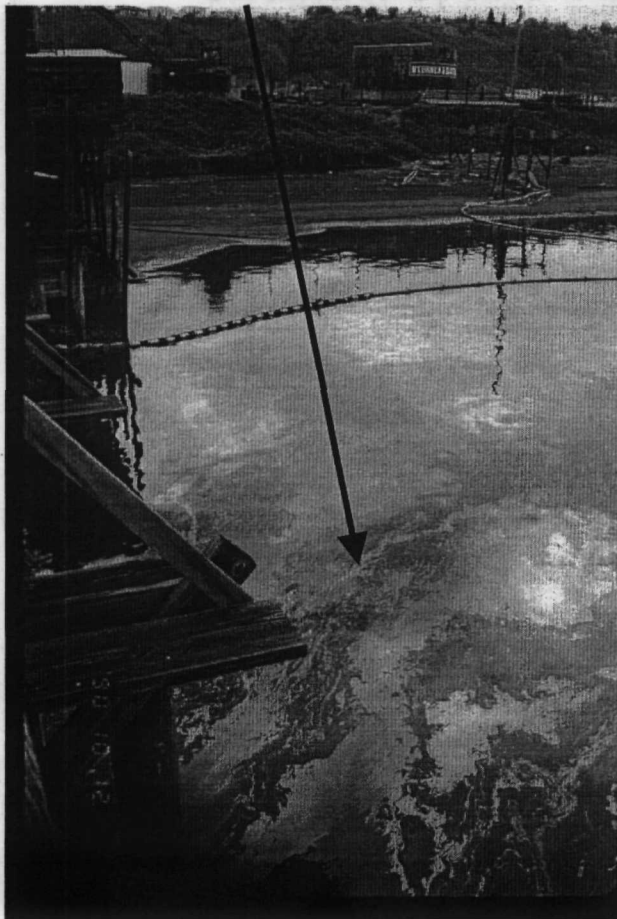
*Oily Sheen during
Wood Treating Operations*

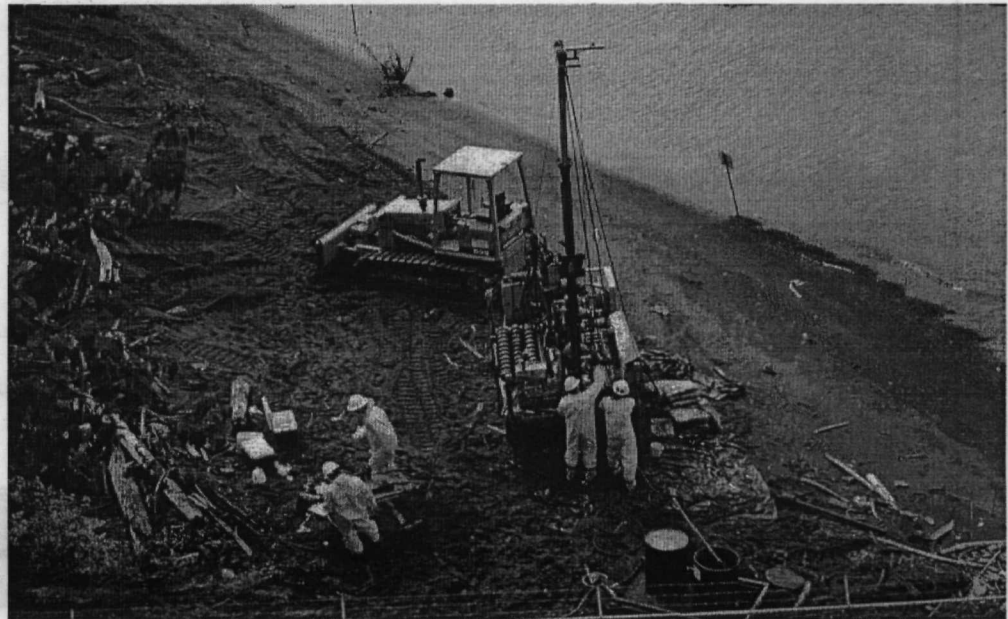
*Monitoring Well Installation
(deep sediment investigation)*

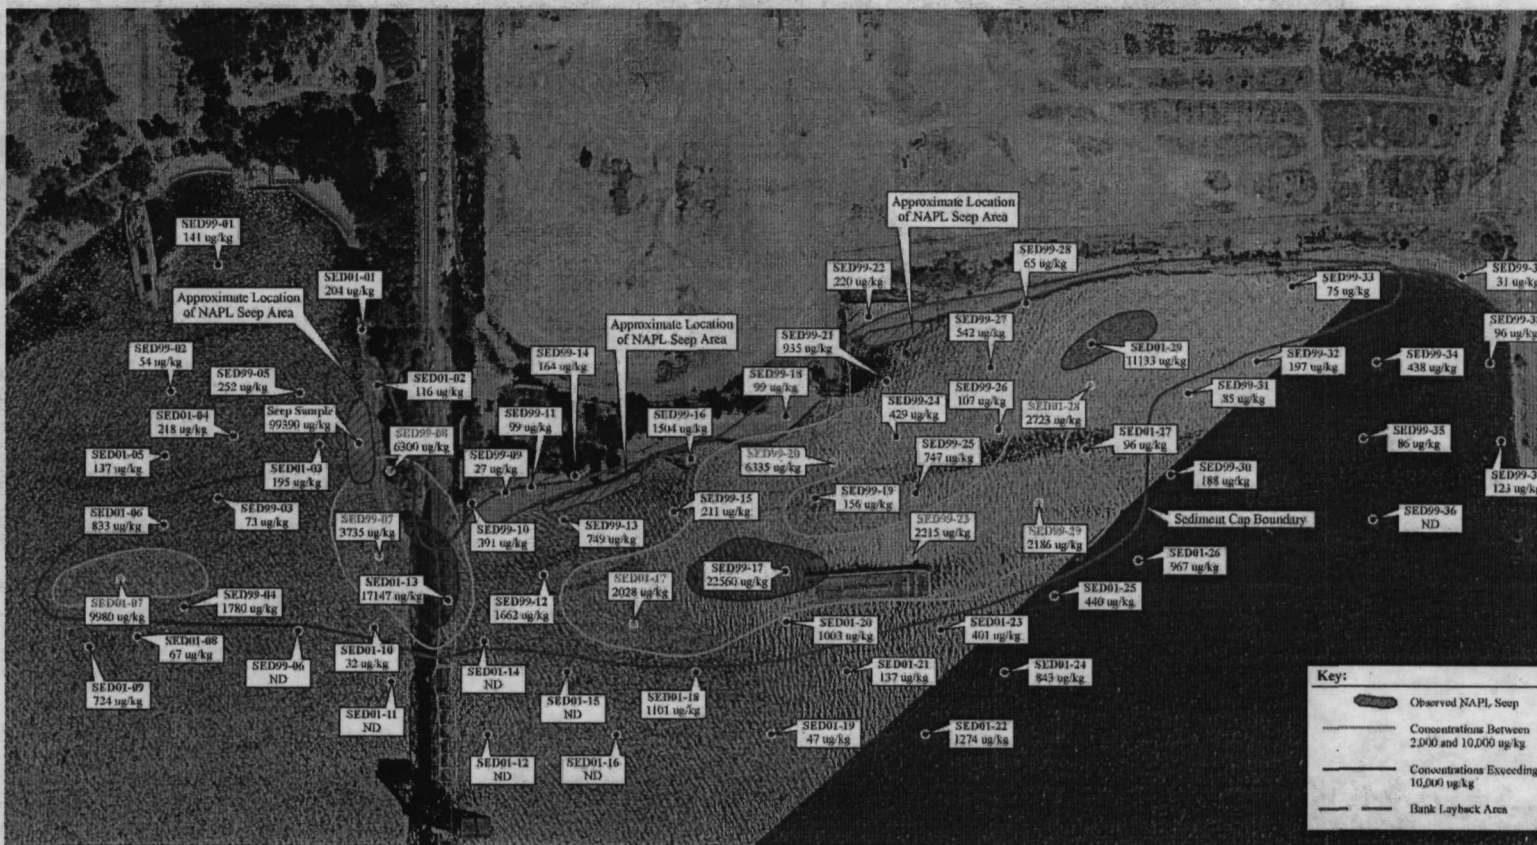
Cap Footprint vs PAHs

1999 AND 2001 SEDIMENT CARCINOGENIC POLYNUCLEAR AROMATIC
HYDROCARBONS CONCENTRATION CONTOUR MAP

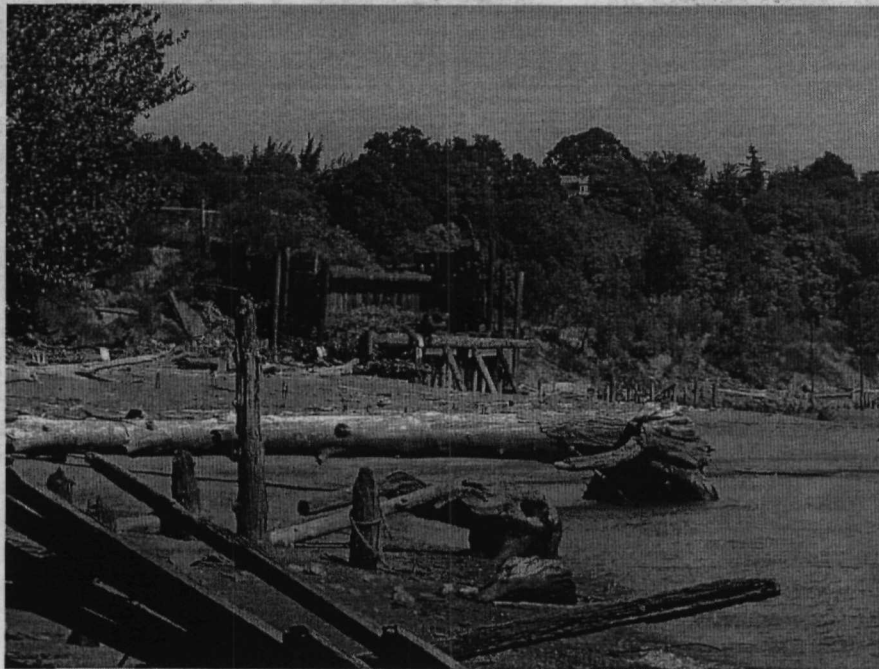
- Removal of unstable wooden bulkhead

Eastward view

Westward view

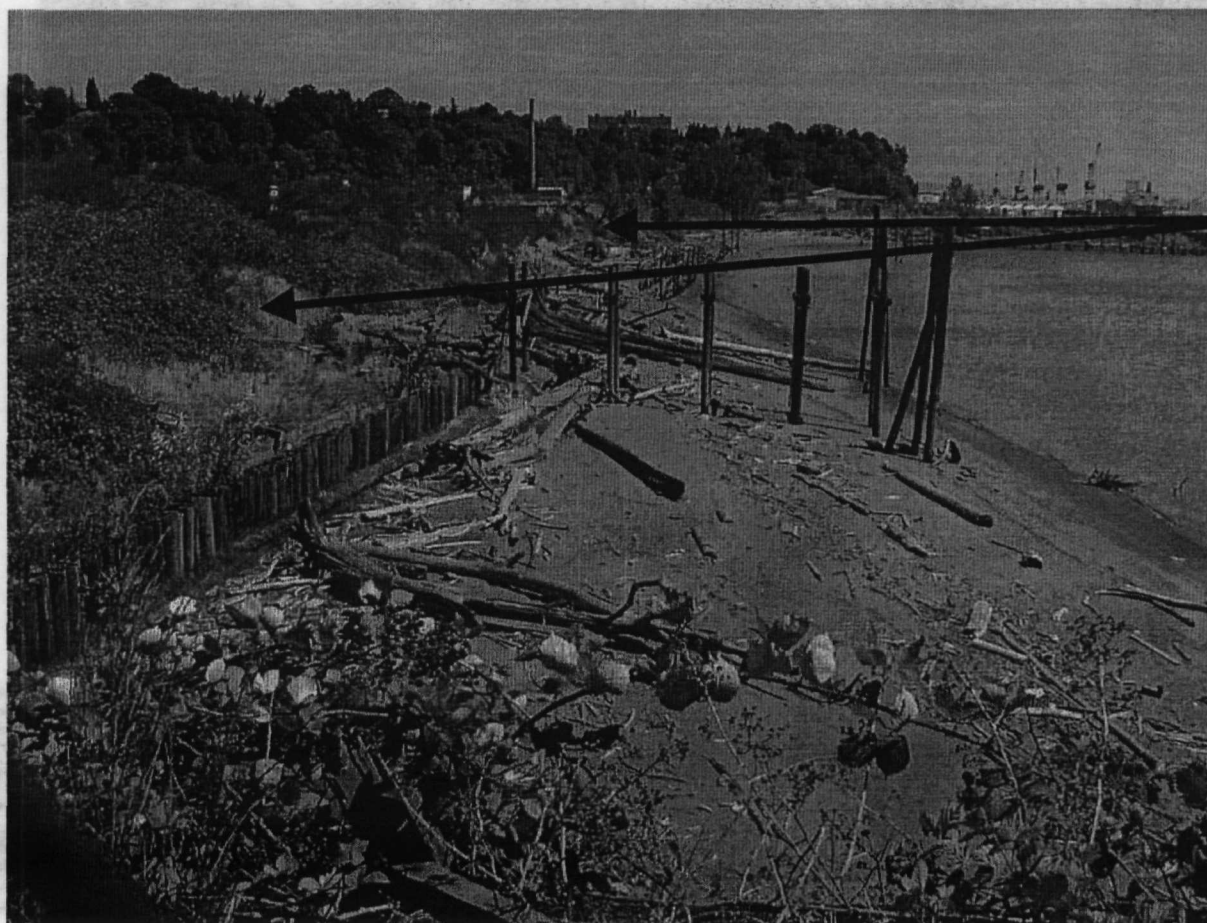
- Layback of unstable bank

Bank

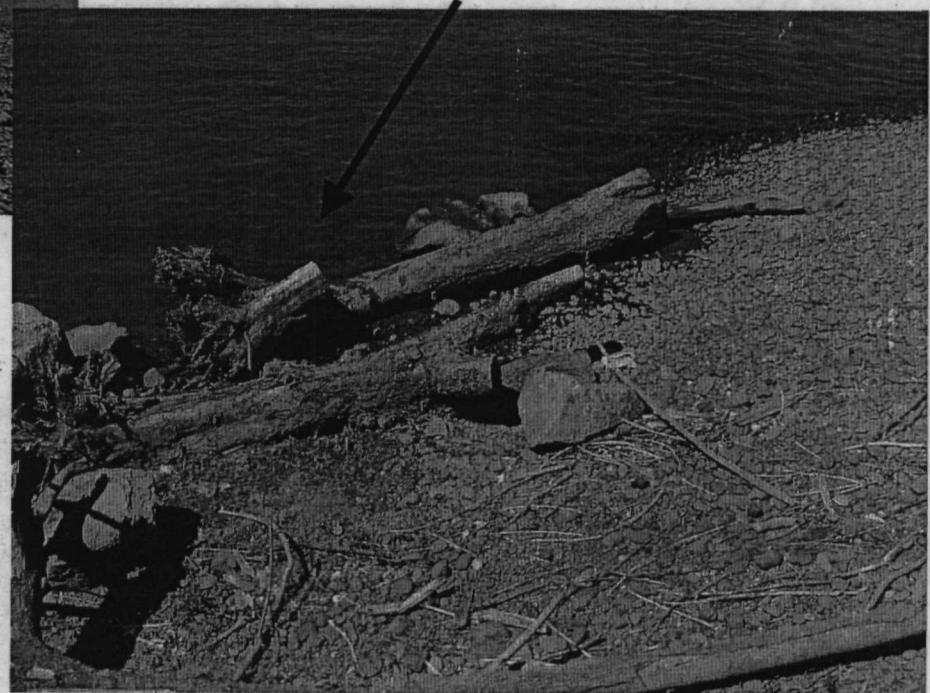
*Bioengineered
Rootball*

*Eastside Esplanade
Riverbank Restoration Project*
